## ESCALATOR STEP DISPLACEMENT'S ACCIDENT: FORENSIC ENGINEERING APPROACH

In Malaysia, escalator accidents caused injuries or fatalities. As a result, a forensic engineering technique was employed to look into the real causes of an escalator malfunction. There was escalator occurred in 2016, KL Sentral. The escalator accident in 2016. The escalator step displacement is the clearance of a step along the vertical and lateral axes. According to BS EN 115-2017, a step's clearance shall be measured. Step alignment of the escalator steps pass through the comb will be affected by step displacement that is outside of the permitted range, either the lateral or vertical direction that led to collision. The alignment of the escalator steps that moving through the comb will be hampered by step displacement that is more than the standard and it may result in a collision between the two parts on either the upper landing platform or lower landing platform. The impact from the collision of steps and combs may also injured escalator passengers. Hence, the clearance of the step in the vertical and lateral direction at any time. It is crucial to inspect and measure the step displacement parameter for

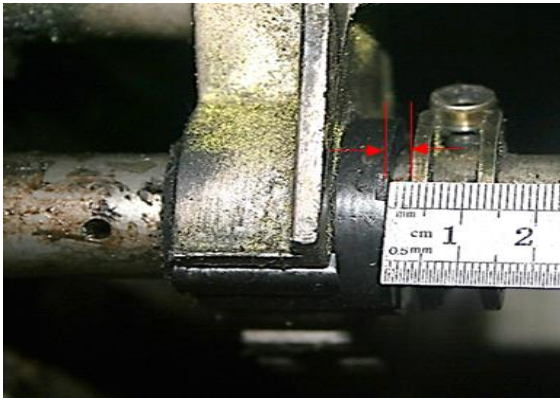
The bush unit and stopper ring are important components in the installation of the step axle slot on the step shaft of an escalator. The position of these components on the step shaft has an impact on the step displacement parameter of the escalator step. Figure 5 illustrates that if there is clearance between the bush and stopper ring during installation, it can result in lateral step displacement. Lateral step displacement refers to the sideways movement of the escalator step. The greater the clearance between the bush and stopper ring, the larger the lateral step displacement will be. This can potentially cause alignment issues and affect the smooth operation of the escalator. On the other hand, Figure 6 demonstrates that clearance between the step axle slot and bush during installation can lead to vertical step displacement. Vertical step displacement refers to the up and down movement of the escalator step. If there is a significant clearance between the step axle slot and bush, it can cause the step to move vertically more than intended. This can also lead to operational problems and discomfort for passengers. To ensure proper functioning and safety of the escalator, it is important to minimize the clearance between the bush and stopper ring as well as the step axle slot and bush during installation. This will help to minimize both lateral and vertical step displacements, resulting in a smoother and more reliable escalator operation.[11]

Figure 5: Bush and Stopper Ring Mounting Clearance

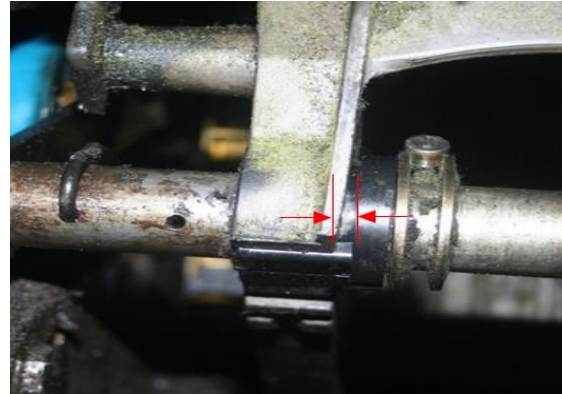
Figure 6: Axle Slot and Bush Mounting Clearance

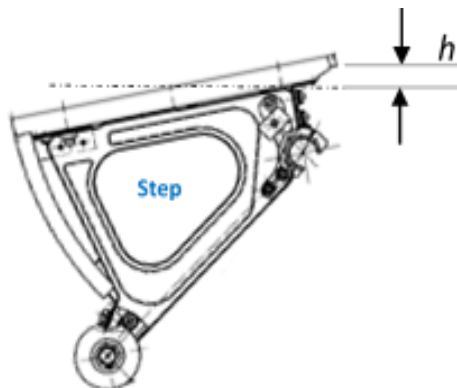
According to code stipulated that the vertical displacement shall not exceed 4 mm. Therefore, if the vertical step displacement ( $h$ ), then the value ( $h$ ) cannot exceed 4mm. [Figure 8]

Figure 8: Measurement of Vertical Step Displacement ( $h$ )

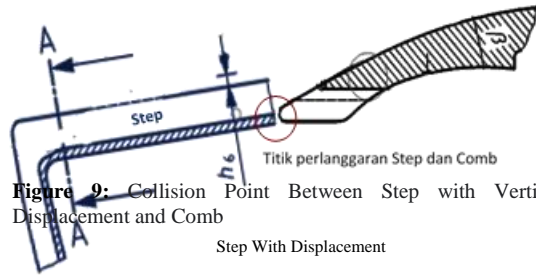
A large vertical step displacement parameter ( $h_6$ ) will indirectly reduce the clearance between the step and the comb ( $h_6$ ) which will then cause a collision between the two components during the step through the comb as shown in Figure 9.

Figure 9: Collision Point Between Step with Vertical Displacement and Comb

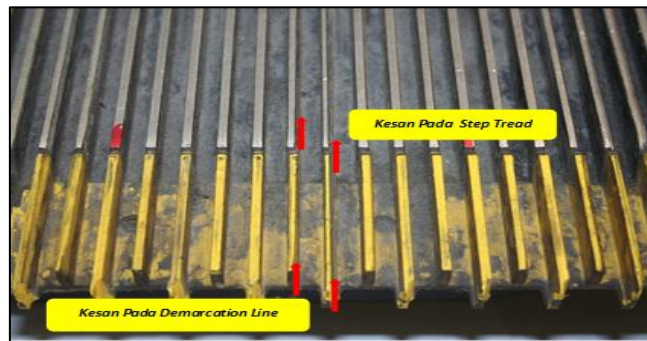
Step units that have step displacement measurement parameters exceed the code will have the following effects. The effects including to the step tread and demarcation which caused the reduction of step width and depth web and severe friction to comb teeth. [Figure 10, 11, 12, 13] [5]

Figure 10: Friction effect on step tread and demarcation line

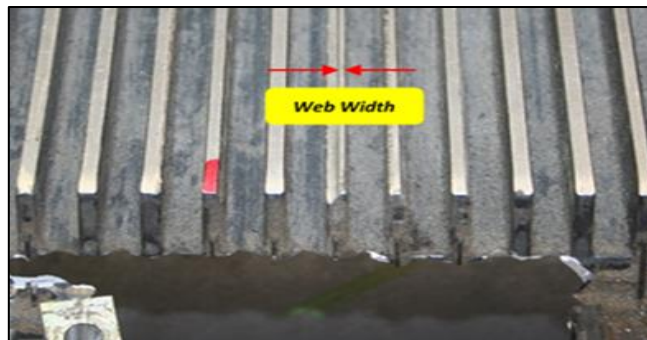
Figure 11: Reduction of step web width parameter

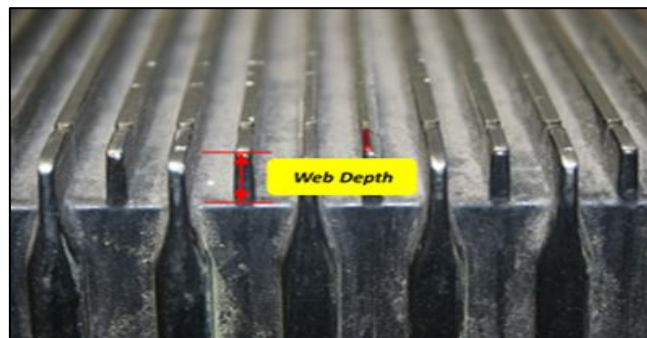
Figure 12: Reduction of step web depth parameter

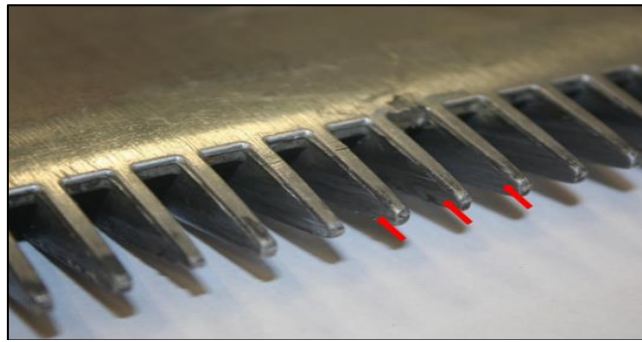
**Figure 13:** Friction effect on comb teeth
