## False Work Accident: Forensic Engineering Investigation Approach

On June 19, 2021, at 7:15 PM, the collapse of a falsework structure at a construction site in Selangor caused one fatality, injured another worker, and severely damaged the falsework. Prior to the collapse, five workers were engaged in pouring concrete into a formwork box at channel P116R. Method of forensic engineering investigation as such by triangulation of approach visual inspections and measurements were conducted on the components used for the falsework structure. A review of technical documents was performed, focusing on the design specifications, engineering drawings, and procedures for the installation of the falsework. A structural analysis was carried out based on the technical data obtained. This study investigates the collapse of a falsework structure at a construction site in Selangor, resulting in one fatality and one injury. Forensic analysis revealed that the structure failed under a concrete load of 32.08 cubic meters (50.74 kN/m<sup>2</sup>), exceeding its capacity. The investigation included onsite inspections, structural analysis, and review of technical documents, concluding that inadequate

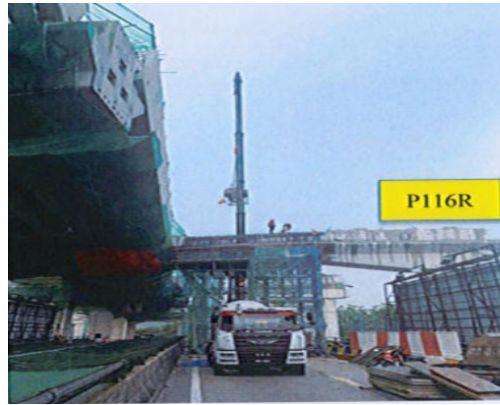
**Figure 1.** Condition before accident

On the day of the incident, five workers were carrying out the task of pouring wet concrete into the segmental Stitching Formwork at channel P116R at around 4:30 PM, using a mobile crane as described below (Figure 1):

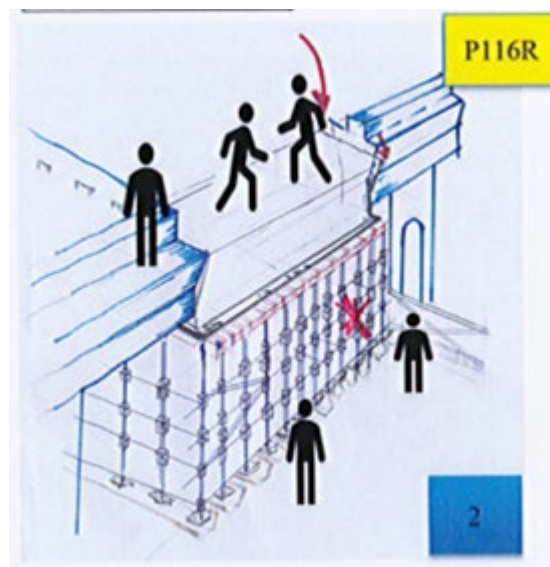
**Figure 5.** Sketch of incident (BEFORE-2)

The activities commenced at 6:50 PM, with the concrete pouring reaching its fourth batch. (Figure 5). The crane operator was actively monitoring the operation. During this time, the operator heard a loud cracking sound. Subsequently, the scaffolding began to gradually collapse, descending towards the ground.

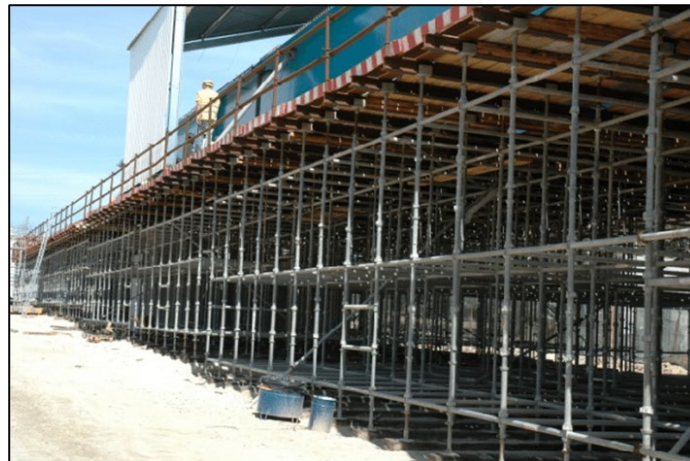
**Figure 8.** Modular scaffolds used as falsework

Falsework, also known as temporary support, structures, refers to a temporary framework used to support a structure during its construction until it becomes self-supporting. Despite being a non-permanent structure that is dismantled after use, falsework performs a critical function like that of a permanent structure. If not properly designed, installed, and managed, falsework poses significant risks, including structural failures and safety hazards. It is important to distinguish between scaffolding and falsework. Scaffolding is primarily used to provide working platforms for construction activities, whereas falsework is specifically designed to support structural elements during construction. However, there is some overlap in their applications. Components of scaffolding systems, such as modular scaffolds, can be utilized as part of falsework systems, and vice versa. For example, as illustrated in Figure 8, falsework may consist of modular scaffold components combined with steel I-beams to support formwork made of timber.

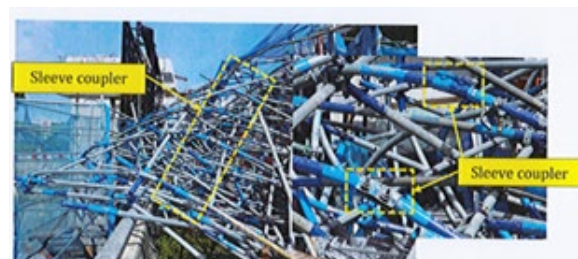
**Figure 9.** Position of sleeve coupler

The inspection revealed that the joint between standards using sleeve couplers on the falsework was employed to achieve the required height (Figure 9). It was also found that some sleeve couplers were torn and bent, as illustrated in Figure 10.

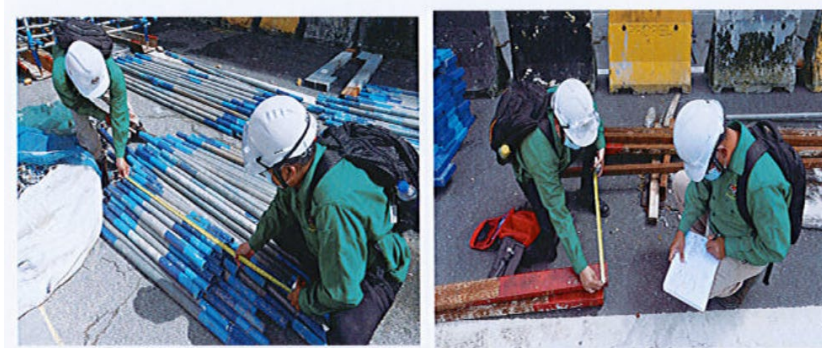
Figure 20. Measurement by Forensic Investigator

Measurements were conducted on a stockpile of tube pipes intended for use in falsework at a nearby collapse site. The results from these measurements indicate a range of tube pipe lengths, including 3 meters, 1.5 meters, 1 meter, 300 cm, and 150 cm. Figure 20.

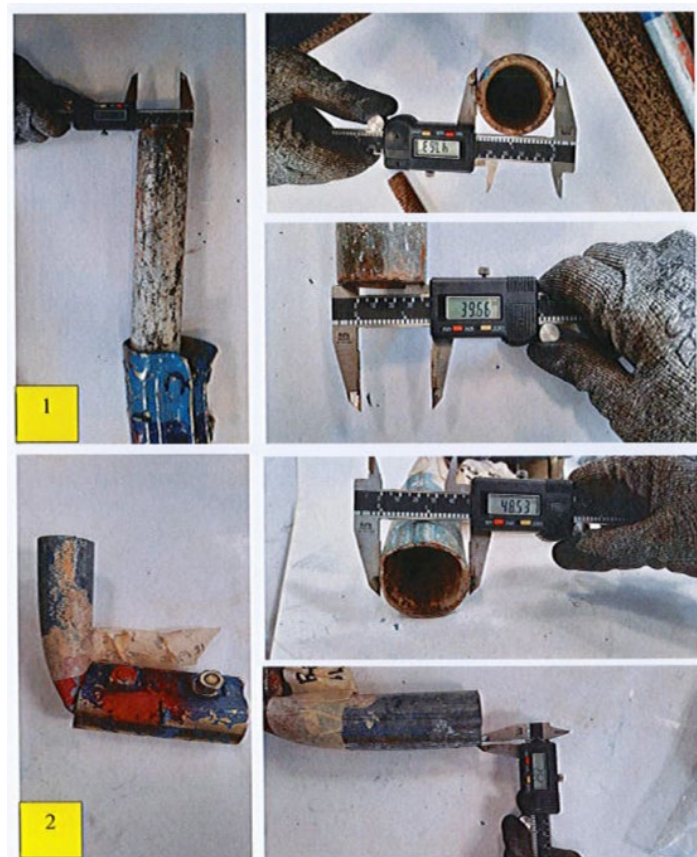
**Figure 24.** Measurement of Extender Tube

Measurements have been taken in terms of outer diameter (OD), inner diameter (ID), and thickness for the extender tube sample obtained from the collapsed falsework structure, as depicted in Figure 24. The measurement results are presented in Table 2.

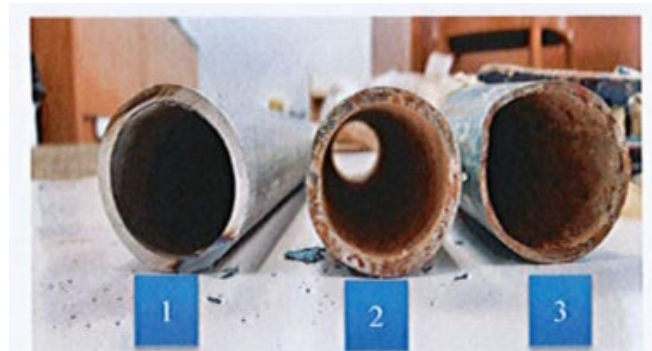
**Figure 25.** Thickness Variation

The results of the measurements for the extender tube and standard indicate a significant difference in thickness, as shown in Figure 25 and Table 3.

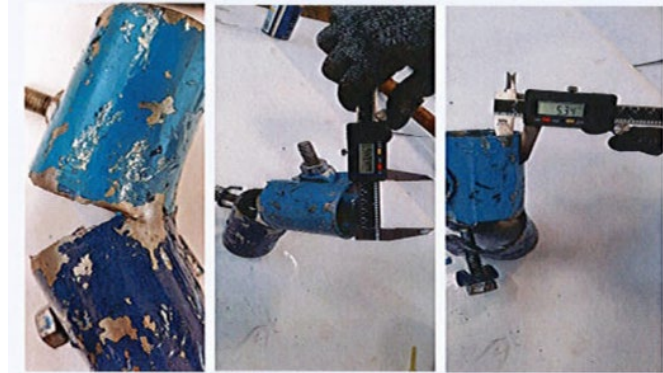
**Figure 27.** Measurement on Sleeve Coupler

Measurements have also been conducted on the outer diameter (OD), inner diameter (ID), and thickness of the sleeve coupler samples collected from the work site, as shown in Figure 27. The measurement results are presented in Table 5.
