## ESCALATOR STEP DISPLACEMENT'S ACCIDENT: FORENSIC ENGINEERING APPROACH

In Malaysia, escalator accidents caused injuries or fatalities. As a result, a forensic engineering technique was employed to look into the real causes of an escalator malfunction. There was escalator occurred in 2016, KL Sentral. The escalator accident in 2016. The escalator step displacement is the clearance of a step along the vertical and lateral axes. According to BS EN 115-2017, a step's clearance shall be measured. Step alignment of the escalator steps pass through the comb will be affected by step displacement that is outside of the permitted range, either the lateral or vertical direction that led to collision. The alignment of the escalator steps that moving through the comb will be hampered by step displacement that is more than the standard and it may result in a collision between the two parts on either the upper landing platform or lower landing platform. The impact from the collision of steps and combs may also injured escalator passengers. Hence, the clearance of the step in the vertical and lateral direction at any time. It is crucial to inspect and measure the step displacement parameter for

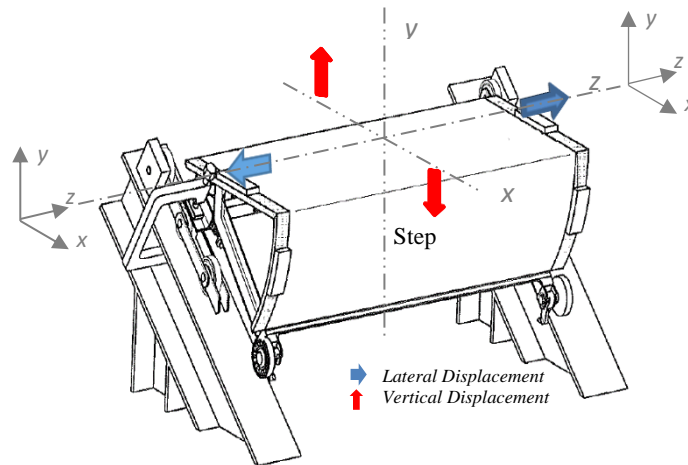
the alignment of the escalator steps while passing through the comb and can cause a collision between the two components. [Figure 1]

Figure 1: Direction of Vertical and Lateral Step Displacement Movement

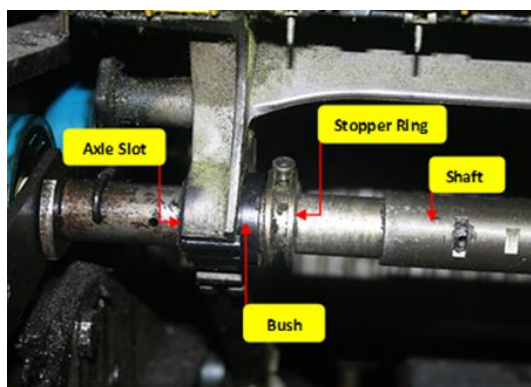
In general, Forensic engineering, in the context of investigating step displacement caused by clearance issues in the installation of the step axle slot on the step shaft, involves a systematic approach to analyzing and determining the root cause of the problem. [Figure 2]

Figure 2: Axle Slot and Step Shaft Positioning

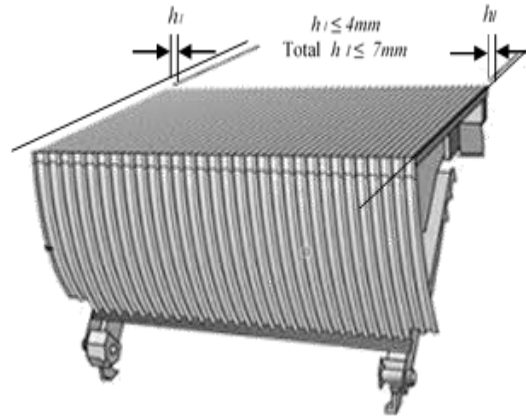
Figure 3: Measurement of Lateral Step Displacement ( $h_1$ )

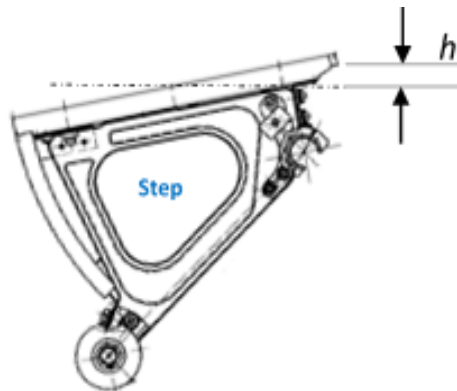
Figure 4: Measurement of Vertical Step Displacement ( $h$ )
